## PHYSICAL NEEDS ASSESSMENT

**PEPPERTREE APARTMENTS**  
4214 East Los Angeles Avenue  
Simi Valley, California 93063

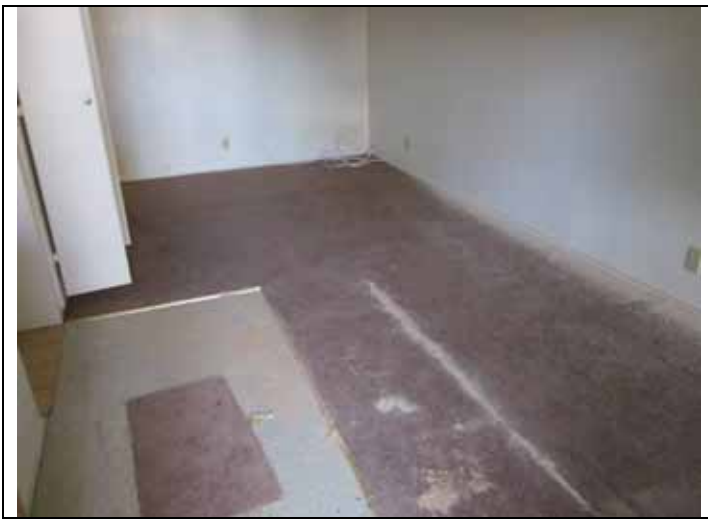
31. Unit 5 living area with worn carpet.

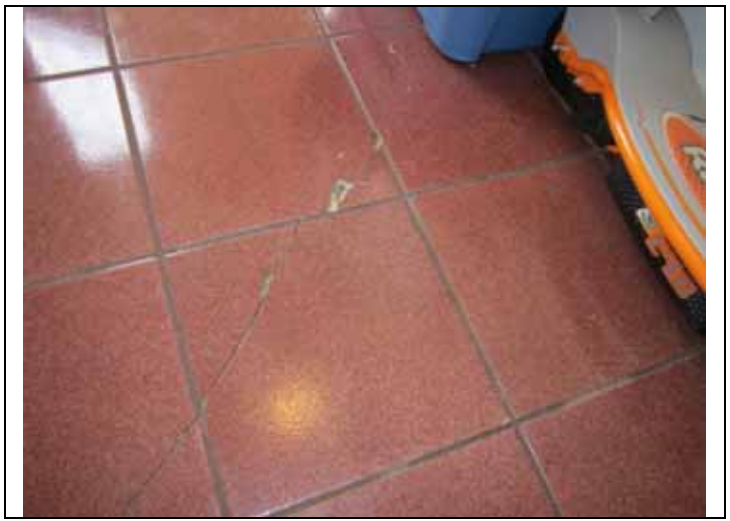
32. Damaged flooring at the entrance to Unit 1.

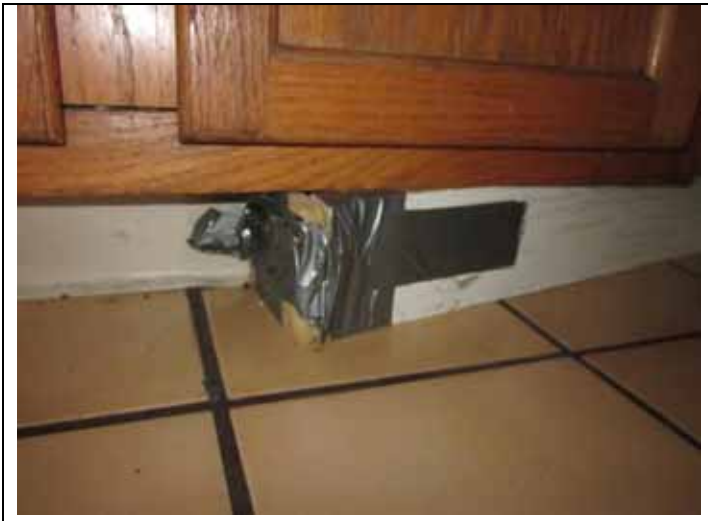
33. Damaged cabinetry at Unit 6 kitchen.

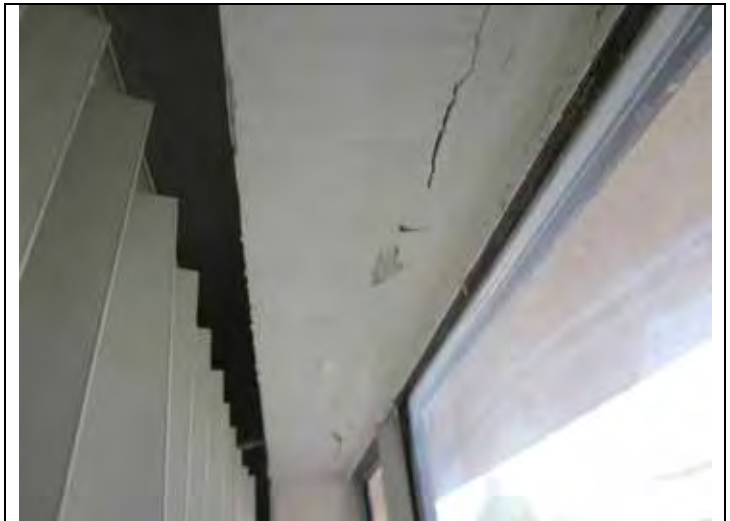
34. Water damage at Unit 3 bedroom upper window framing.

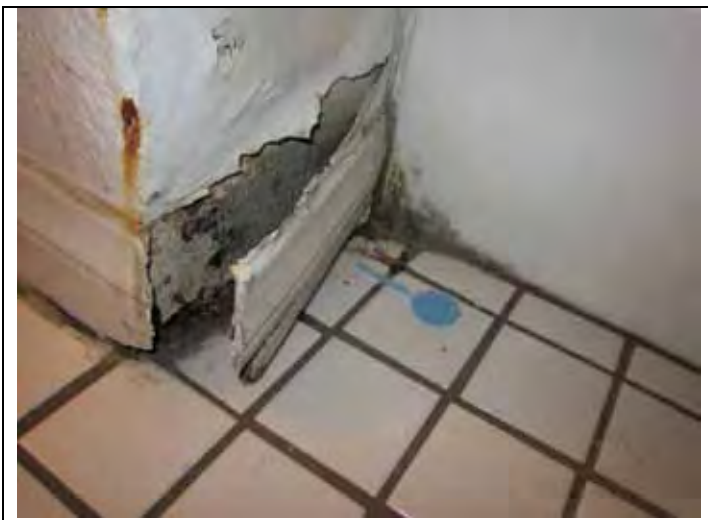
35. Water damage at Unit 3 bathroom near base of the tub.

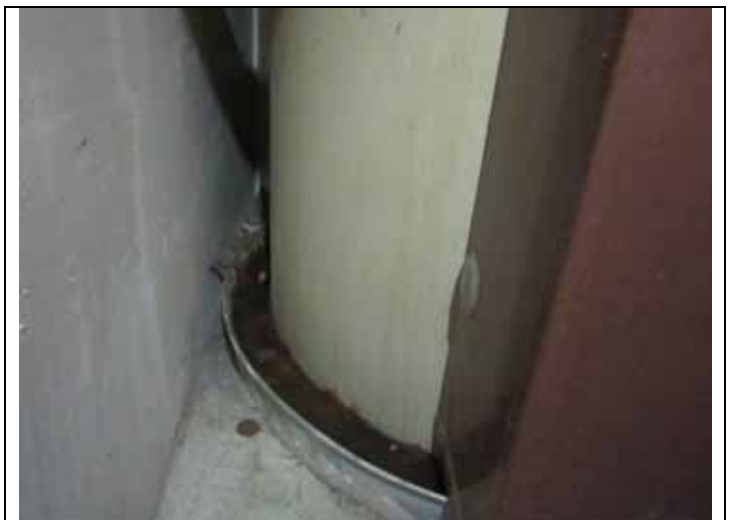
36. Water in the drip pan at Unit 3 water heater indicating leak.

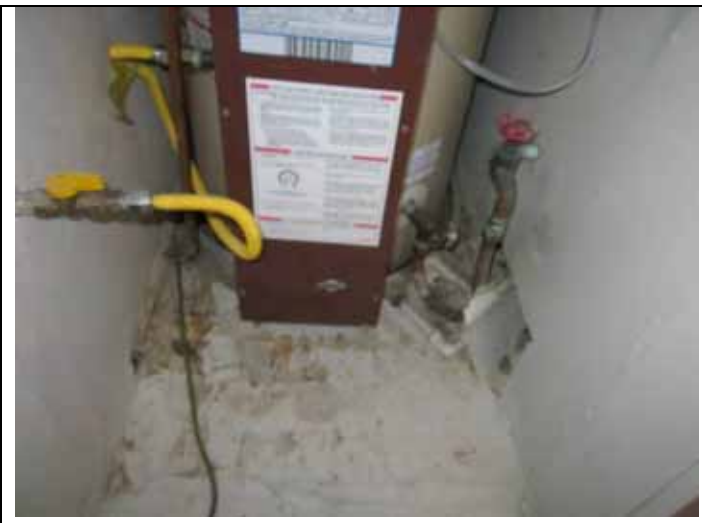
37. Moisture damage at the water heater closet floor at Unit 10.

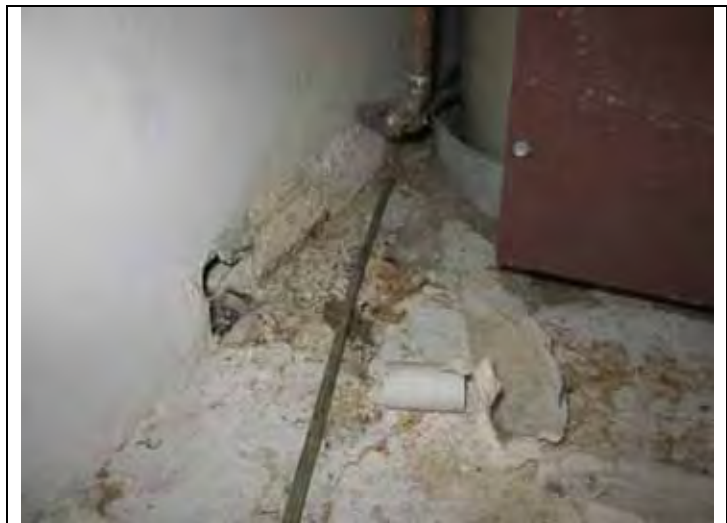
38. Drywall damage at Unit 10 water heater closet.

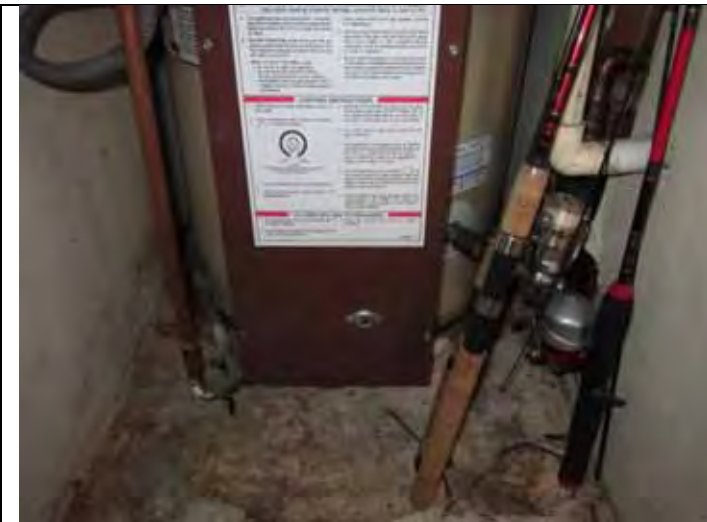
39. Moisture damage at Unit 1 water heater closet.

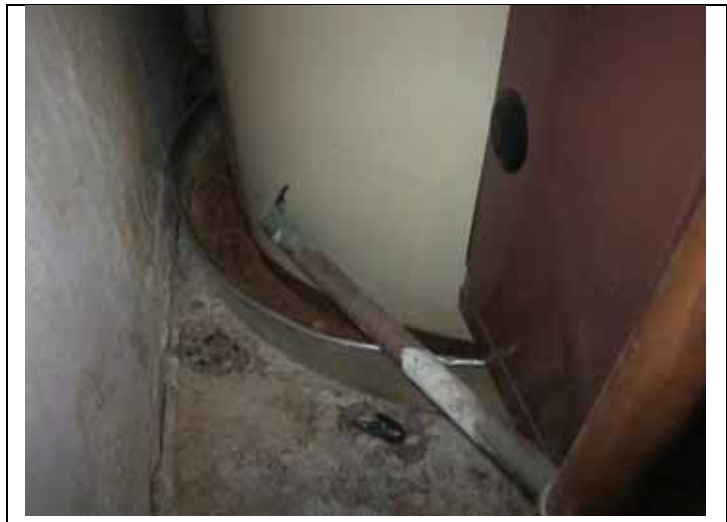
40. Water and corrosion in the drip pan at Unit 1 indicating long term leak.

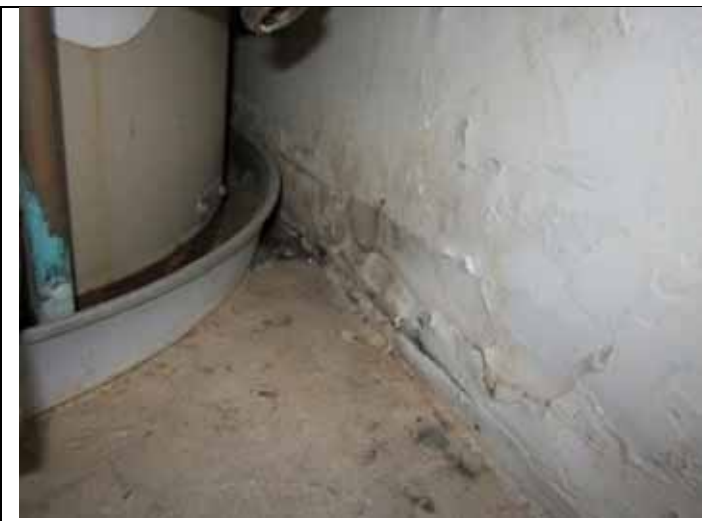
41. Moisture damage at Unit 6 water heater closet.

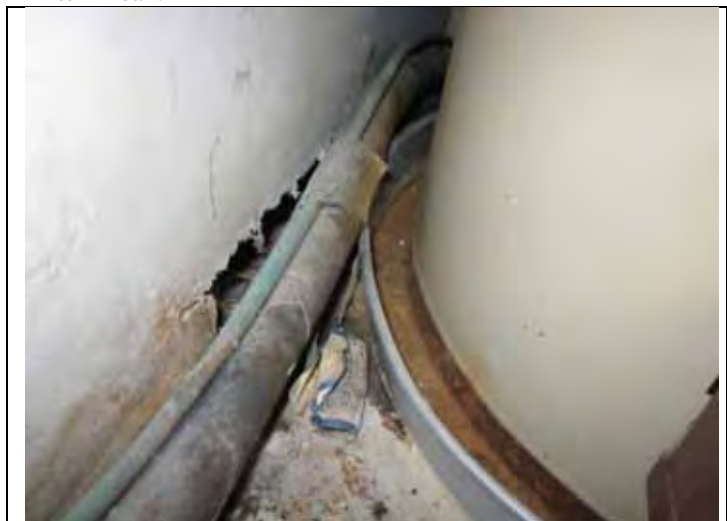
42. Drywall damage at Unit 6 water heater closet.

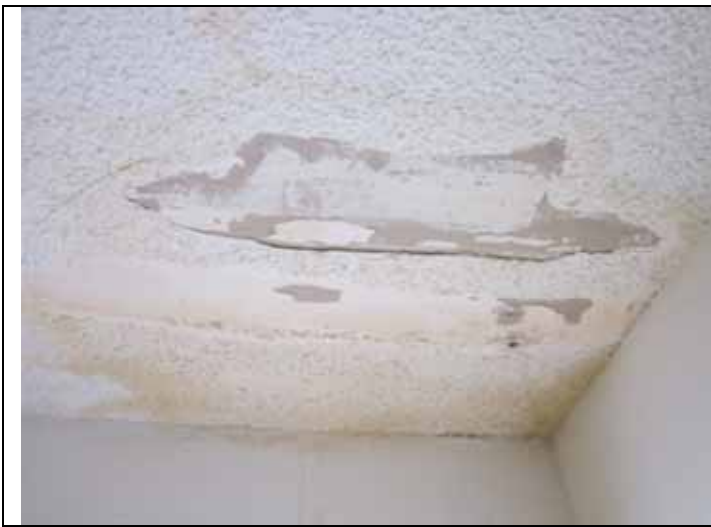
43. Moisture damaged ceiling at Unit 9 entry.

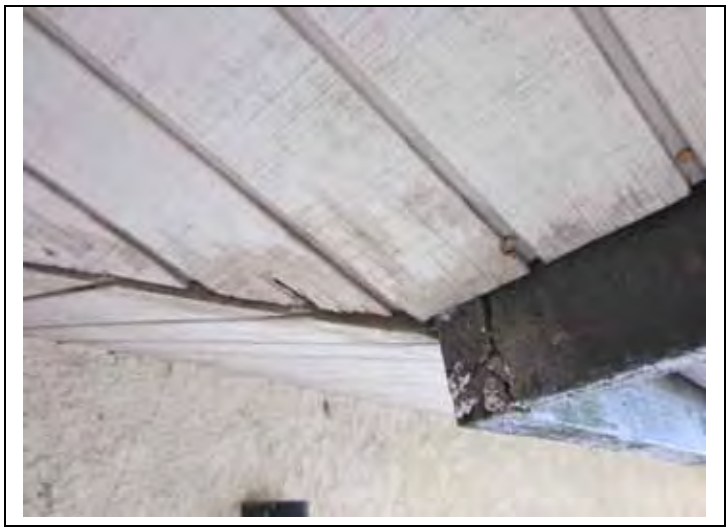
44. Moisture damage at the soffit area at the corner of the building near Unit 9.

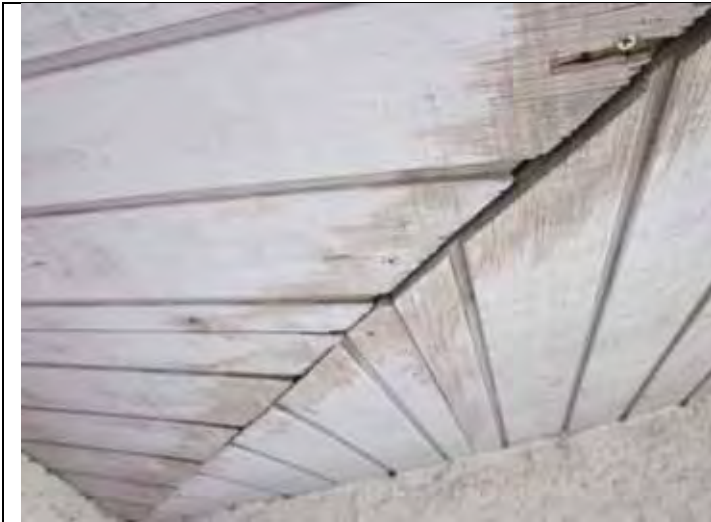
45. Another view of the moisture damage at the soffit area at the corner of the building near Unit 9 indicating roof leak.

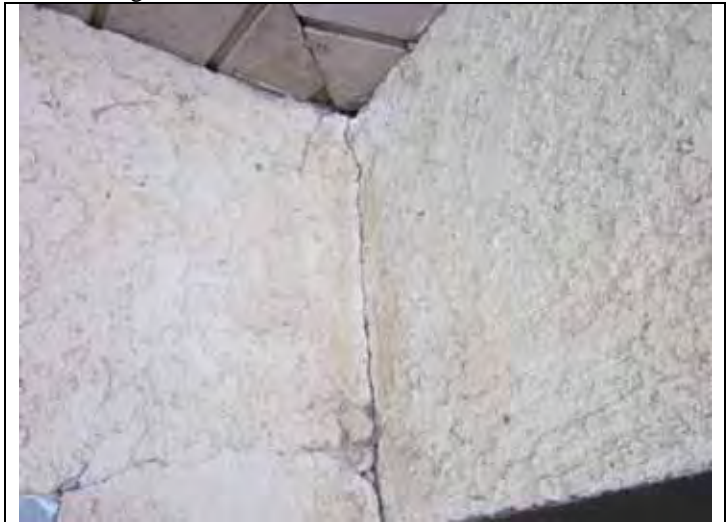
46. Stucco damage and moisture staining near the soffit area at the corner of the building near Unit 9.

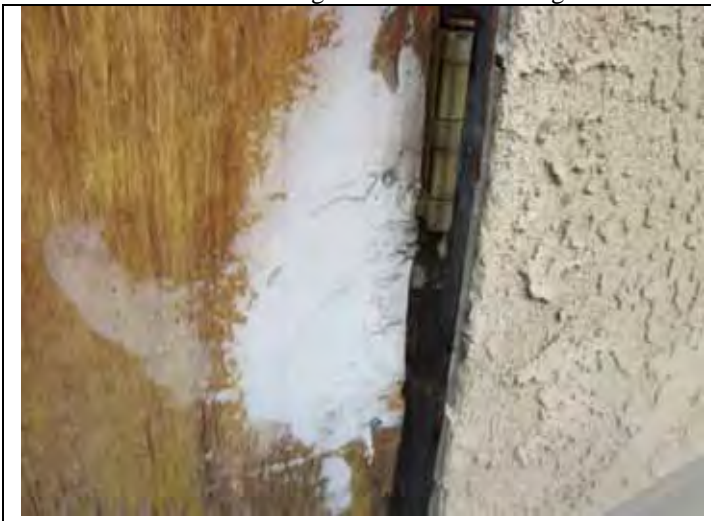
47. Damaged door at Unit 2.

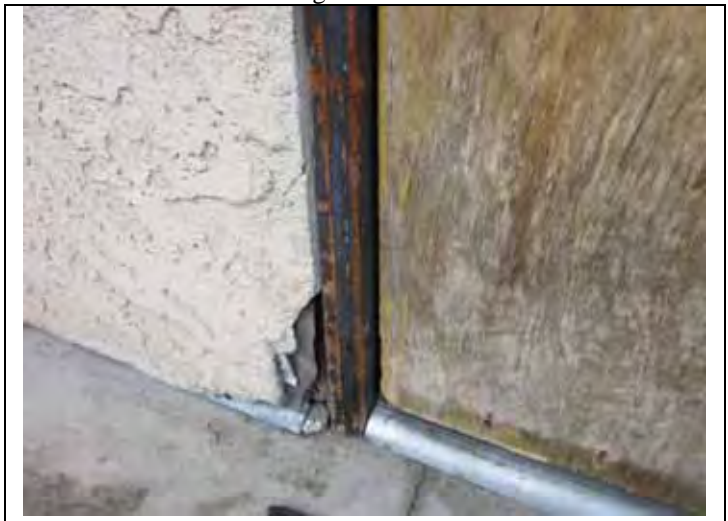
48. Example of typical stucco damage observed near door framing.

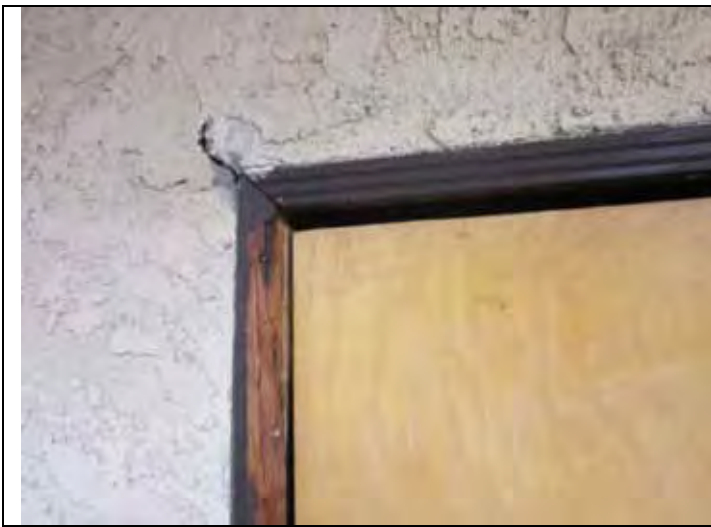
49. Another example of stucco damage near door framing.

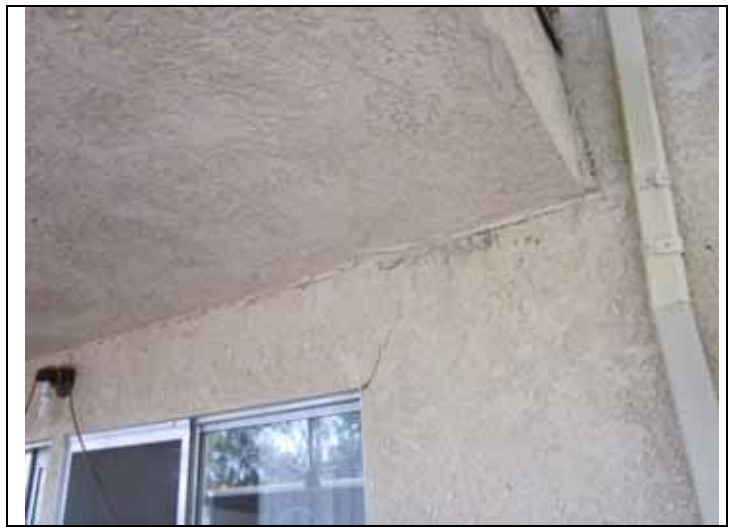
50. Stucco cracking near window framing.

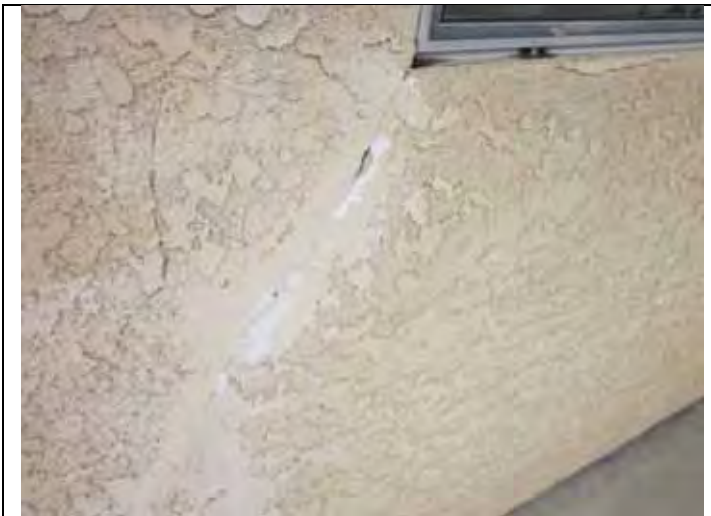
51. Another example of cracked stucco at window framing.

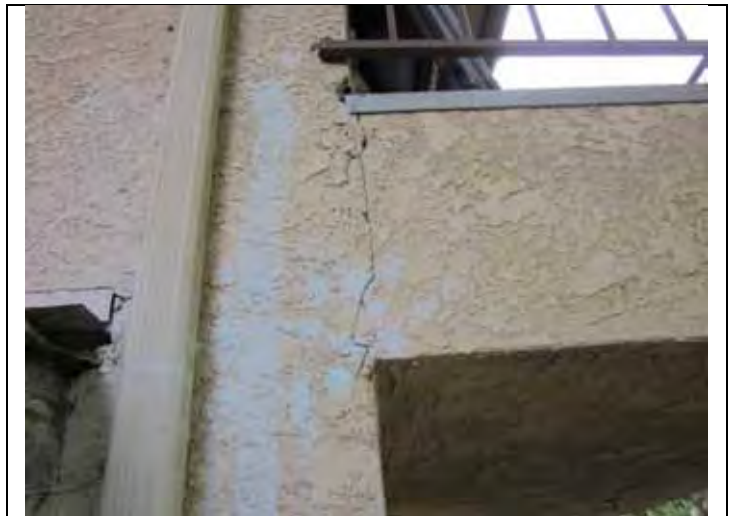
52. Stucco cracking at the northwest corner of the building near Unit 12 balcony.

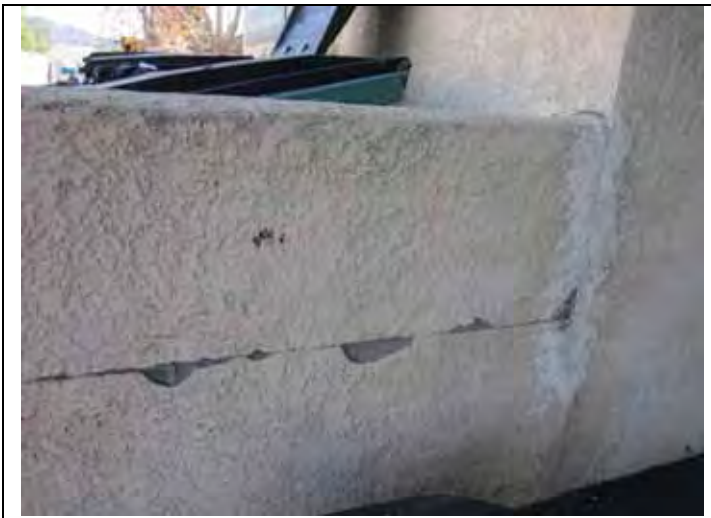
53. Stucco damage at the trash dumpster enclosure wall.

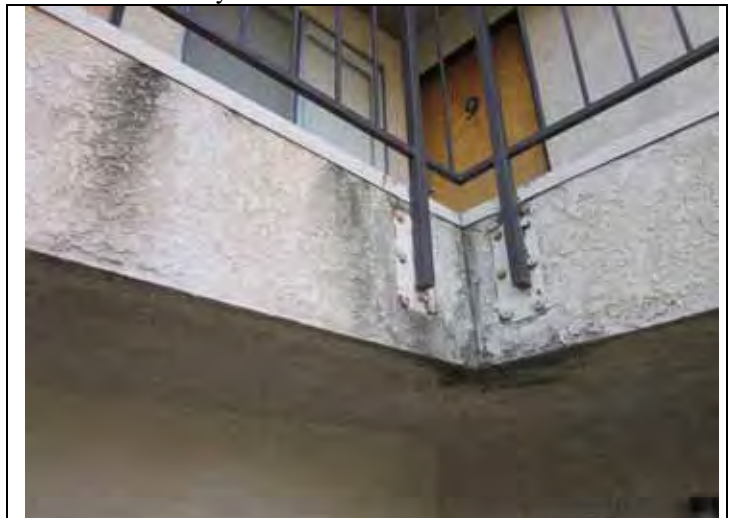
54. Staining typical along the upper level walkway.

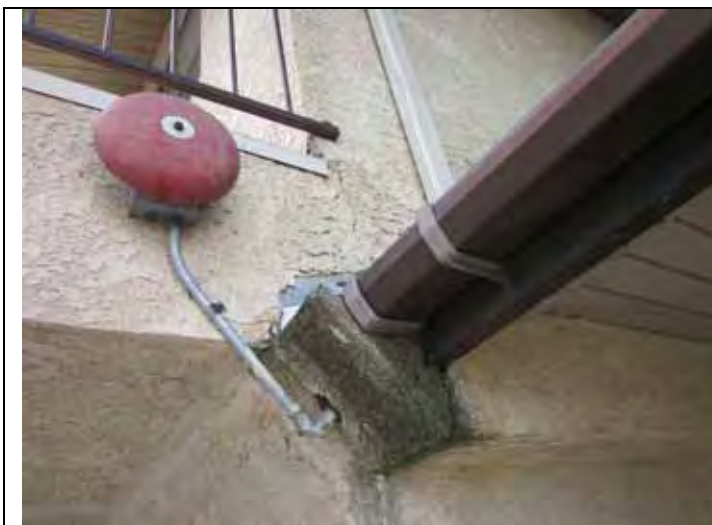
55. Stucco damage and staining where the west carport adjoins the building.

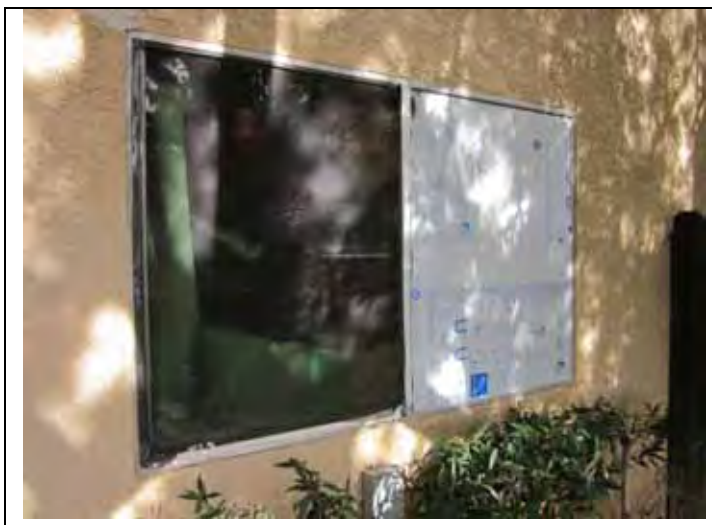
56. Broken window replaced with plastic (Lexan) sheet at southwest corner of the building, Unit 4.

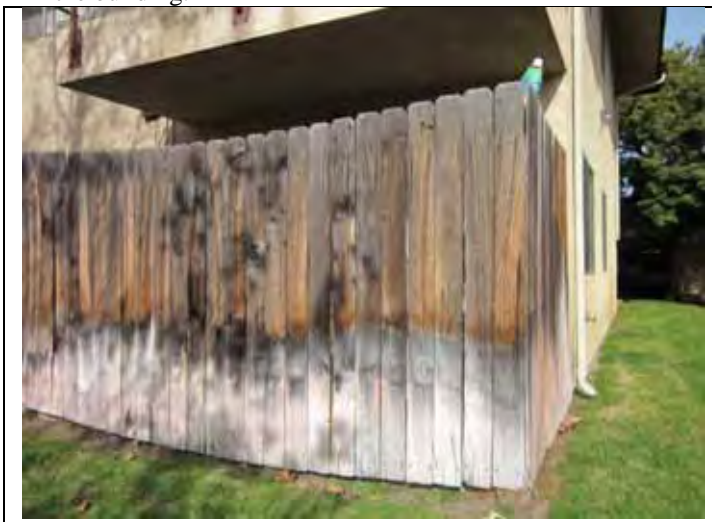
57. Example of wood damage typical at the patio fencing.

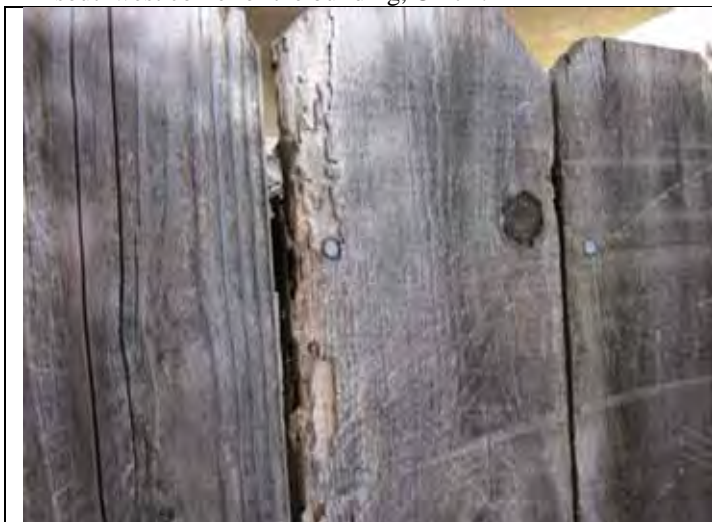
58. Evidence of potential wood-destroying organisms at the patio fencing.
